Manhole Inspection Summary

Manhole # S43OO_008MH

Insp Date: **12/18/07 9:25 AM**

Location Address: **25th-Normal**

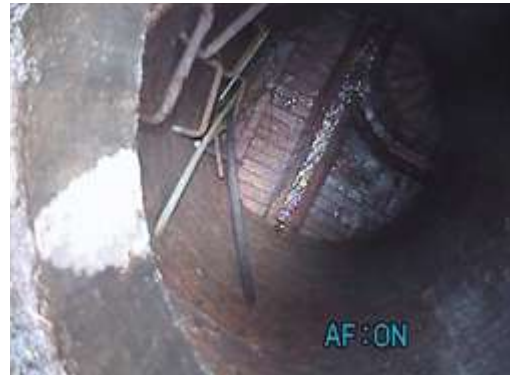
Top View

Frame Offset: **4** (in.) Condition: ☐ Sound ☐ Cracked ☒ **Leaks**

Infiltration: ☐ None ☒ **Joint** ☐ Cracks ☐ Mortar ☐ Roots ☐ Wall

Infiltration: ☐ None ☐ Joint ☐ Cracks ☐ Mortar ☐ Roots ☒ **Wall**

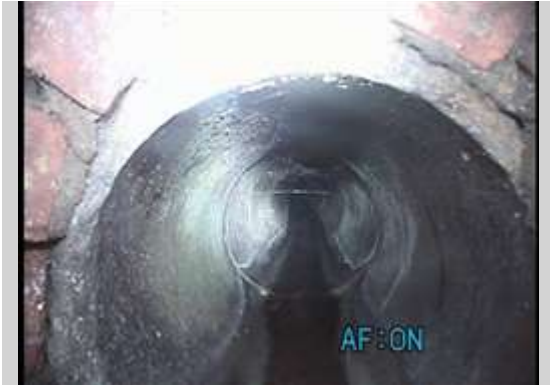
12 O'Clock Outflow

8 in. Circular Gravity Sewer
Pipe Out @ 12 O'Clock

Pipe Height: **8.4** (in.) Rod and Bar (Angled)

Pipe Material: **Clay** ☐ Pipe Lined

Invert Depth: **10.90** (ft.) Flow Characteristics: **Slow**

Infiltration: **None** Pipe Seal Cond: **Sound**

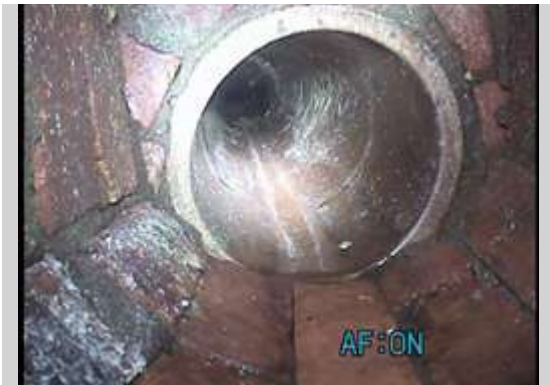
3 O'Clock Inflow

6 in. Circular Gravity Sewer
Pipe In @ 3 O'Clock

Pipe Height: **6** (in.) Rod and Bar (Angled)

Pipe Material: **Clay** ☐ Pipe Lined

Invert Depth: **10.60** (ft.) Flow Characteristics: **None**

Infiltration: **None** Pipe Seal Cond: **Sound**

Connects To: **House connection / Service line**

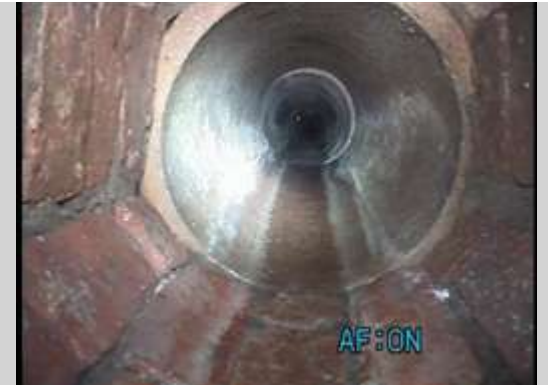
6 O'Clock Inflow

8 in. Circular Gravity Sewer

Pipe In @ 6 O'Clock

Pipe Height: **8.4** (in.) Rod and Bar (Angled)

Pipe Material: **Clay** ☐ Pipe Lined

Invert Depth: **10.70** (ft.) Flow Characteristics: **Slow**

Infiltration: **None** Pipe Seal Cond: **Sound**
